CITY OF OMAHA
NPDES PERMIT FOR THE MUNICIPAL SEPARATE
STORM SEWER SYSTEM (MS4)
NE0133698
2011 ANNUAL REPORT

April 1, 2012

**PERFORMANCE ASSESSMENT OF
TWO STORMWATER BEST MANAGEMENT PRACTICES
FOR INFILTRATION, WATER QUALITY, AND VEGETATIVE GROWTH**

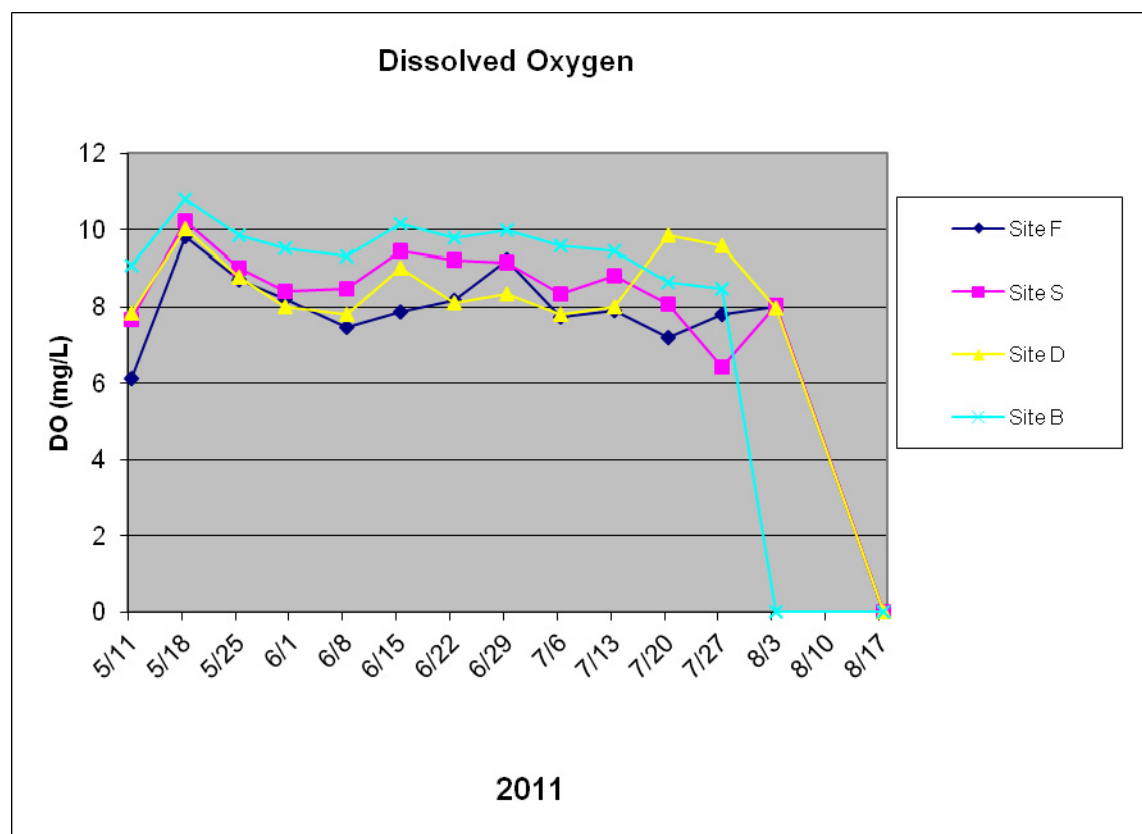
Dissolved Oxygen 2011

Site F	Site S	Site D	Site B
5/11/2011	6.13	7.68	7.84	9.09
5/18/2011	9.81	10.22	10.02	10.78
5/25/2011	8.72	9.02	8.78	9.87
5/31/2011	8.2	8.41	7.99	9.51
6/8/2011	7.47	8.47	7.8	9.32
6/15/2011	7.87	9.45	9	10.16
6/22/2011	8.17	9.23	8.09	9.8
6/29/2011	9.23	9.14	8.34	9.99
7/6/2011	7.74	8.35	7.8	9.59
7/13/2011	7.9	8.8	7.99	9.46
7/20/2011	7.2	8.06	9.84	8.66
7/27/2011	7.81	6.43	9.59	8.49
8/3/2011	8.02	8.05	7.97	---
8/17/2011	---	---	---	---
Average	8.02	8.56	8.54	9.56

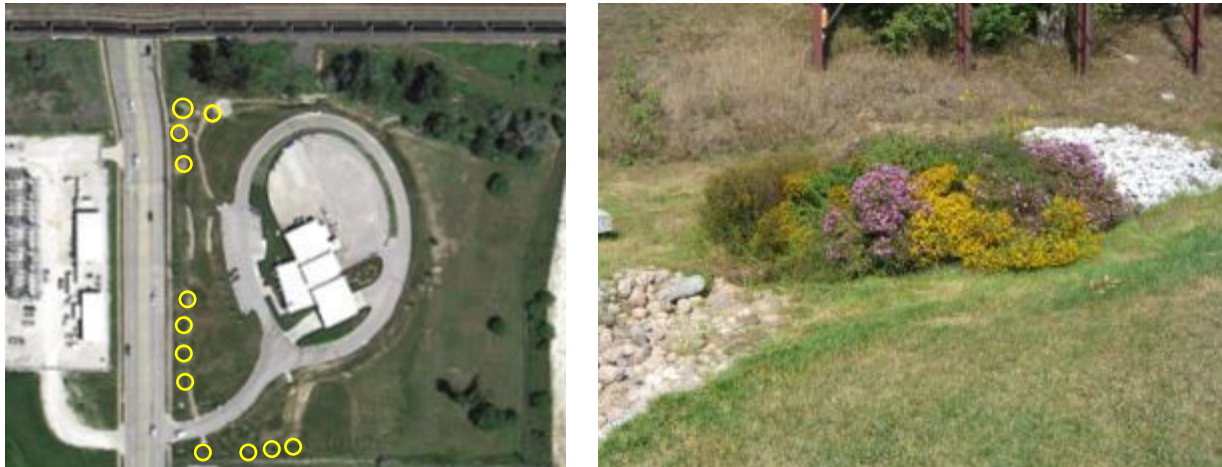
Figure2-2: Under the Sink Bioretention Gardens (aerial photo source: Google Earth)

The Under the Sink facility is a household hazardous waste collection facility operated by the City of Omaha located at 4001 South 120th Street, occupying approximately 5.5 acres. The land has moderate slope to the west, and consists primarily of the building, parking lots, and turf lawn. A series of 15 bioretention gardens were constructed in 2008 at the site along the west and south boundaries of the property, adjacent to 120th Street (Figure 2-2).

The bioretention gardens are generally about 20 feet in diameter, and were constructed in a silty clay loam soil. The bioretention gardens were constructed with flexible, perforated drainage pipe installed in an oval configuration at the bottom of each garden, connected with a solid four inch drainage pipe that runs to the nearest storm sewer inlet. Pea gravel was installed over the perforated pipe, geotextile laid over top of the aggregate and stapled down, and then backfilled with a compost/sand mixture. The ponding depth of each garden is approximately six inches. Vegetative growth in the bioretention gardens was observed to be good at the time of sampling, with some sparsely vegetated areas in two of the gardens. Vegetation in the gardens included Helen's Flower, New England Aster, Bee Balm, Spiderwort, and Golden Alexanders.

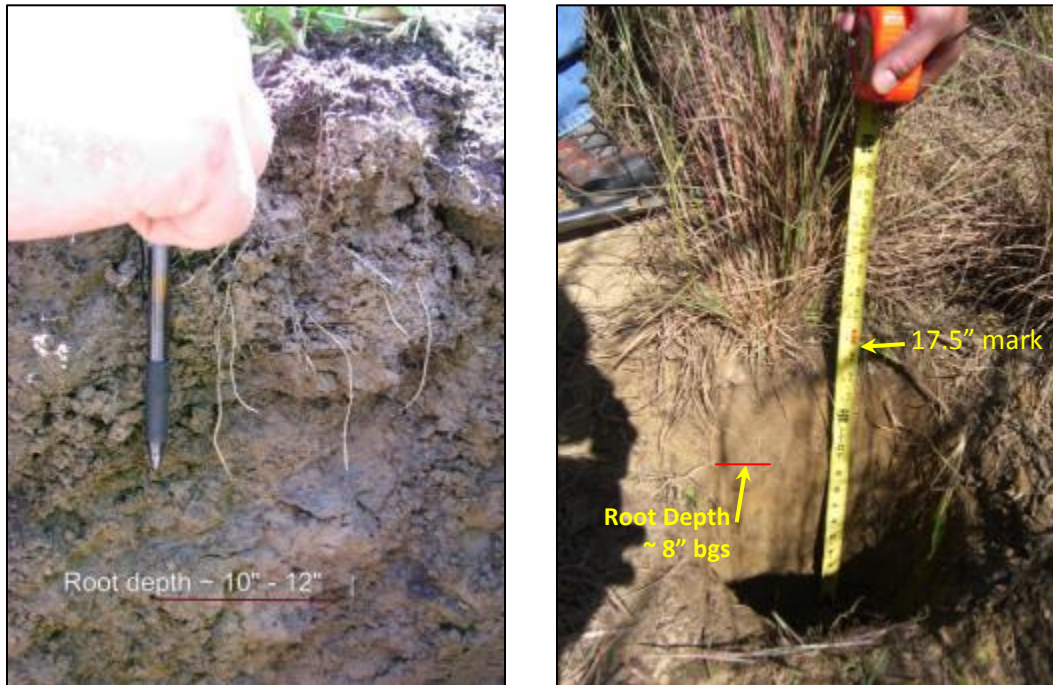
Figure 4-2: Root growth in uncompacted native soil (left) and compacted native soil (right)

- Root growth was good, with plants within the infiltration cell showing excellent root growth and structure. Plants growing in the native silty clay soil also showed very good growth, with roots found as deep as 12 inches below the ground surface. Roots of little bluestem growing in areas of the garden that have compacted soils also showed root growth to depths of 6- to 8 inches below the ground surface (bgs), demonstrating the hardiness of these plants to grow even in difficult soil conditions (Figure 4-2).
