# UNO Baxter Arena Bioretention Gardens

2425 S 67<sup>th</sup> Street, Omaha, NE

City of Omaha Stormwater Program & University of Nebraska - Omaha

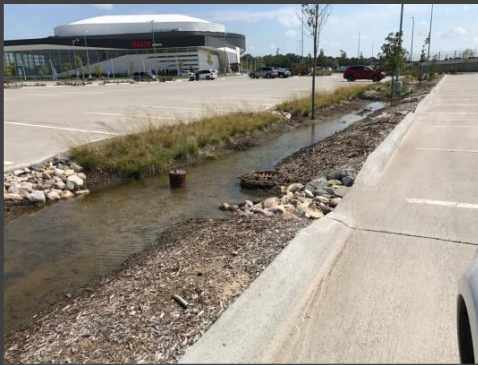
Water logged bioretention systems in northwest parking lot

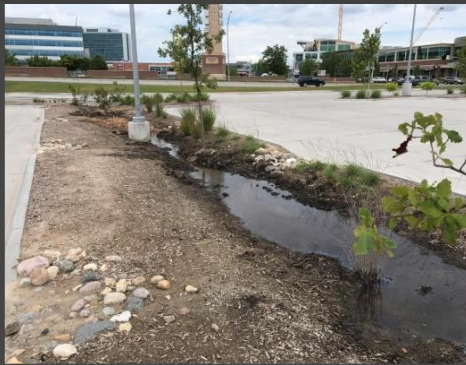
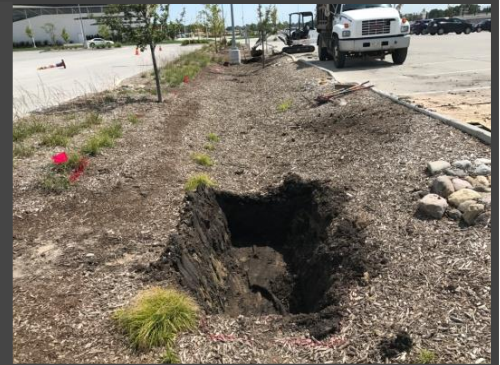
Excavated section of infiltration cell

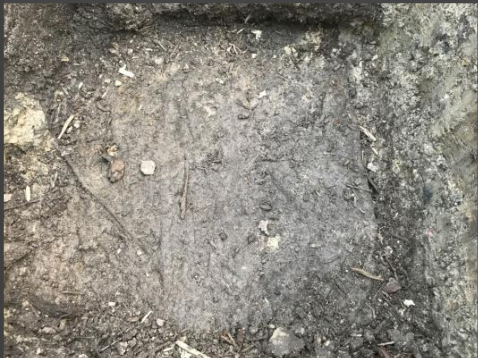
After examining the bioretention systems there were three main issues as to why they did not drain: (1) a nonwoven geotextile was laid flat over the drainage aggregate resulting in it being clogged from the beginning, (2) the Bioretention Soil Mixture (BSM) included 1/3 top soil which had an unknown texture leading to a slower percolation rate, and (3) the inlets into the bioretention system were eroding, causing sediment deposition and clogging of the infiltration cell.

Clogged geotextile on top of the aggregate  
(Note that the geotextile is flat across the top)

Once all problems were identified, a plan was developed to fix and improve permeability/infiltration rates within the bioretention systems. Rather than reconstruction the entire infiltration cell, the plan was to repair portions of it to allow for better drainage into the underdrain system. First, three sections of the BSM were excavated and hauled off. Second, the existing geotextile was cut and removed. Third, the existing drainage aggregate was evaluated and additional rock was added to create a convex mound and increase surface area for better drainage. Next, a woven geotextile, designed for subsurface drainage, was placed over the drainage aggregate. Fifth, a new BSM of 80/20, sand/compost was placed into each excavated infiltration cell section. Finally, each repaired sections was plugged with palm and fox sedge, and a thin layer of mulch was placed on top.

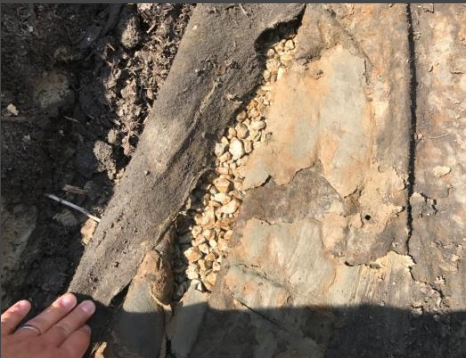
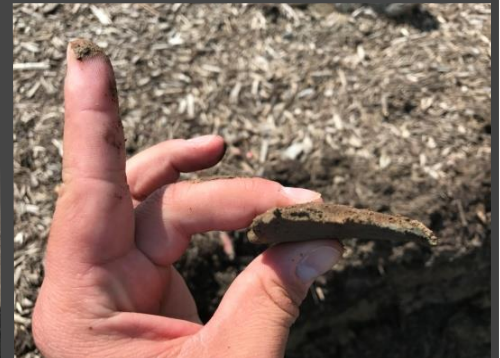
Thick deposits of clay and silt found on top of geotextile

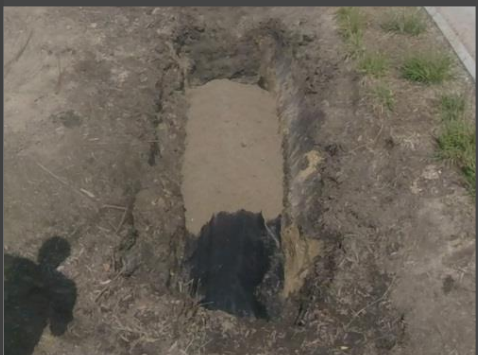
New 80/20, sand/compost BSM being installed

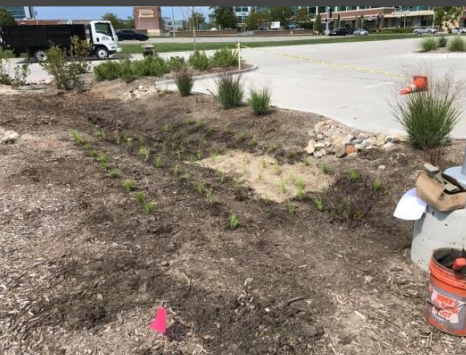
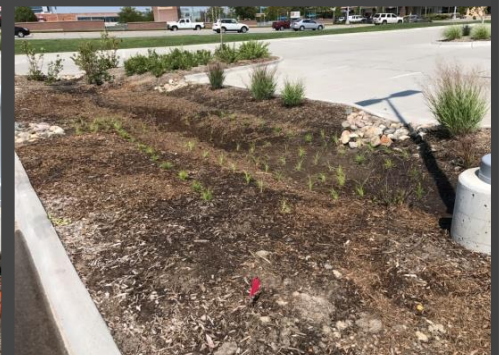
Palm and Fox sedge plugs and thin layer of mulch placed on top of repaired sections within the bioretention system
